# State of Utah DEPARTMENT OF NATURAL RESOURCES Division of Oil, Gas & Mining

## Inspection Report Minerals Regulatory Program June 30, 2011

Mine Name: Bromide Basin	Permit Number: S0170031 Inspection Date: June 21, 2011 Time: 10:40 am – 12:10 PM Mine Status: Active		
Operator Name: Bromide Mining LLC			
Inspector(s): Wayne Western			
Other Participants: Sue Fivecoat (BLM), Shane Scott (Permitteee)

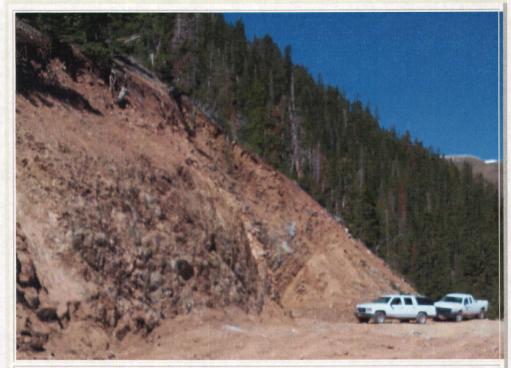
The portals were gated. There are no highwalls at the mine. However the portal face up areas are steep and there is the potential for rock fall.

Portal face up area.
